Photo Gallery

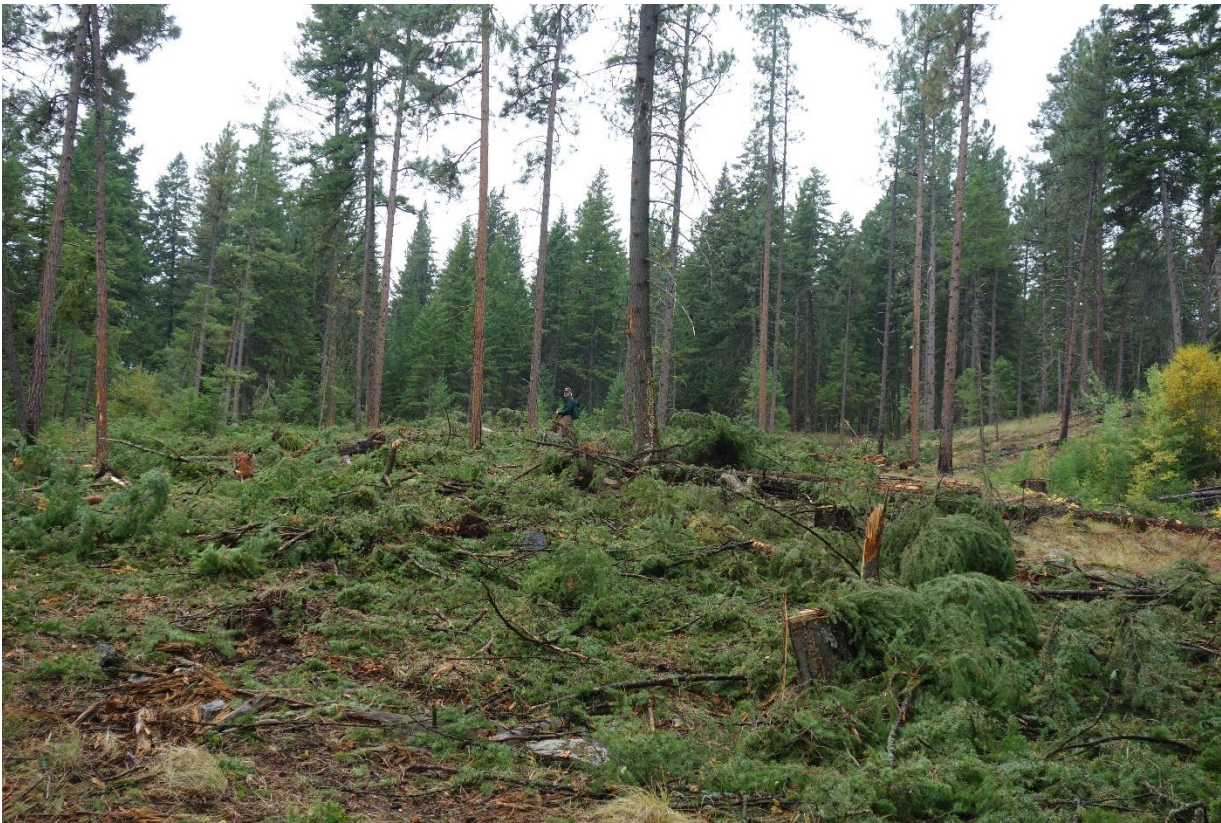
Southwestern corner of the shaded fuel break. There's not much shade, with lots of slash still on the ground three weeks after fuel break was started. Person for scale in center of photo. Most of the larger, fire-resistant trees have been cut. Photo 10-1-2022.

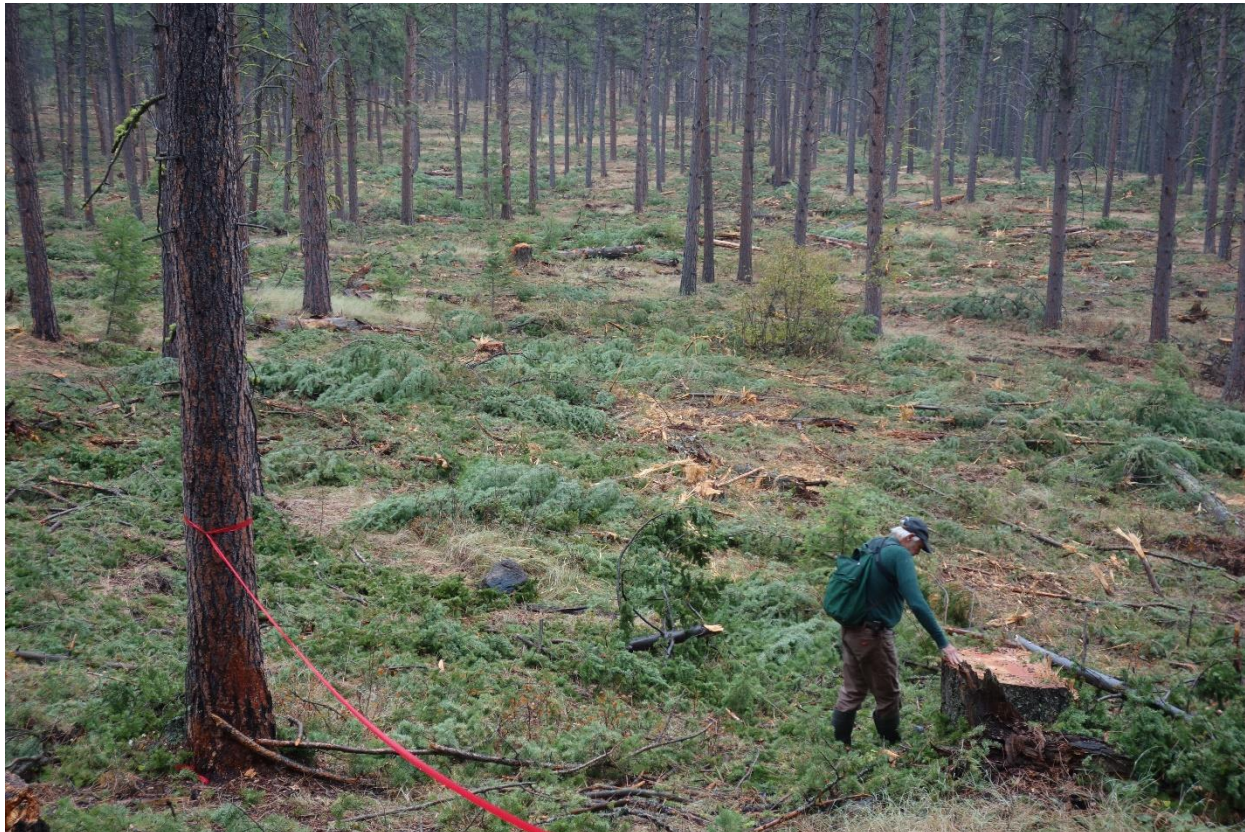
Eastward view of the commercial logging area, which extends beyond the upper edge of the photo. The largest and most fire-resistant trees have been cut. BNF's own definition of shaded fuel break posted on Inciweb on 9-19 is:

"mechanically created buffer zones that remove shade tolerant brush, but mature trees that are more fire resistant are left standing." Many stumps like the one in the foreground had been 100-130 years old. Note large amount of slash still on the ground. Photo 10-1-2022.

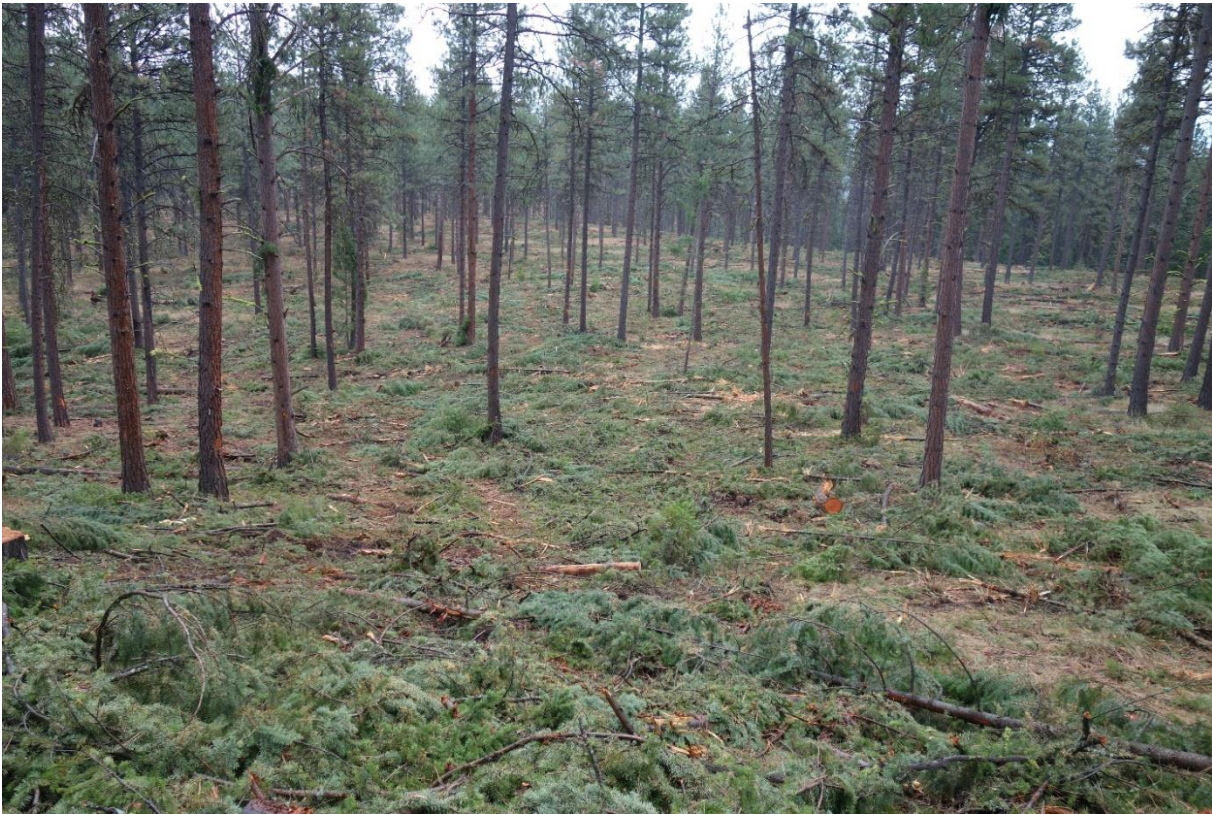
View east from the western edge of the shaded fuel break. Note large amount of slash remaining three weeks after this fire line was deemed necessary. Photo 10-1-2022.

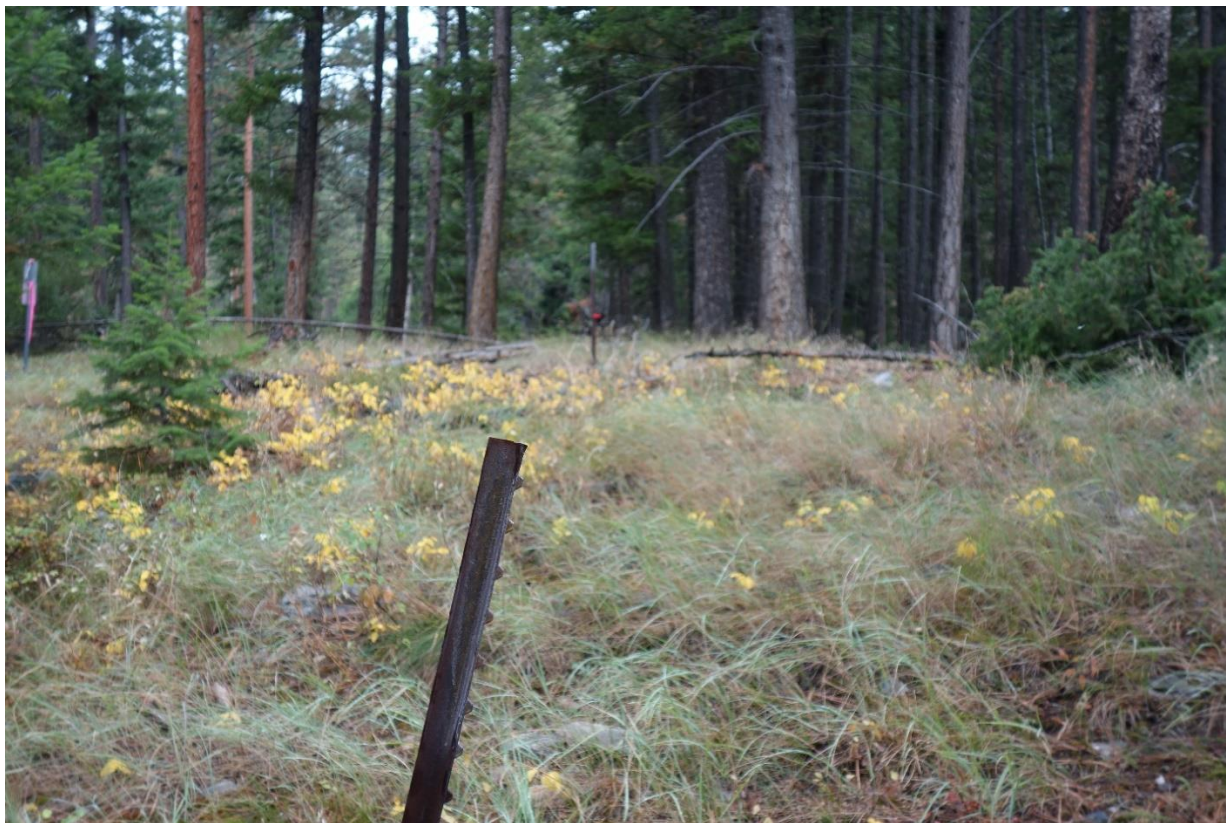
View west along the forest boundary at the southwest corner of the commercial logging area. National forest lands on the right (north). Note that no work has been done farther west and south along the boundary, an observation

confirmed by Inciweb maps. The fence line was erected to mark the private-public land boundary. A later survey must have found it was farther south (left) as seen by the National Forest sign with new pink flagging near the left edge of the photo, making almost the entire photo national forest. The forest here consists mostly of small, crowded Doug firs.

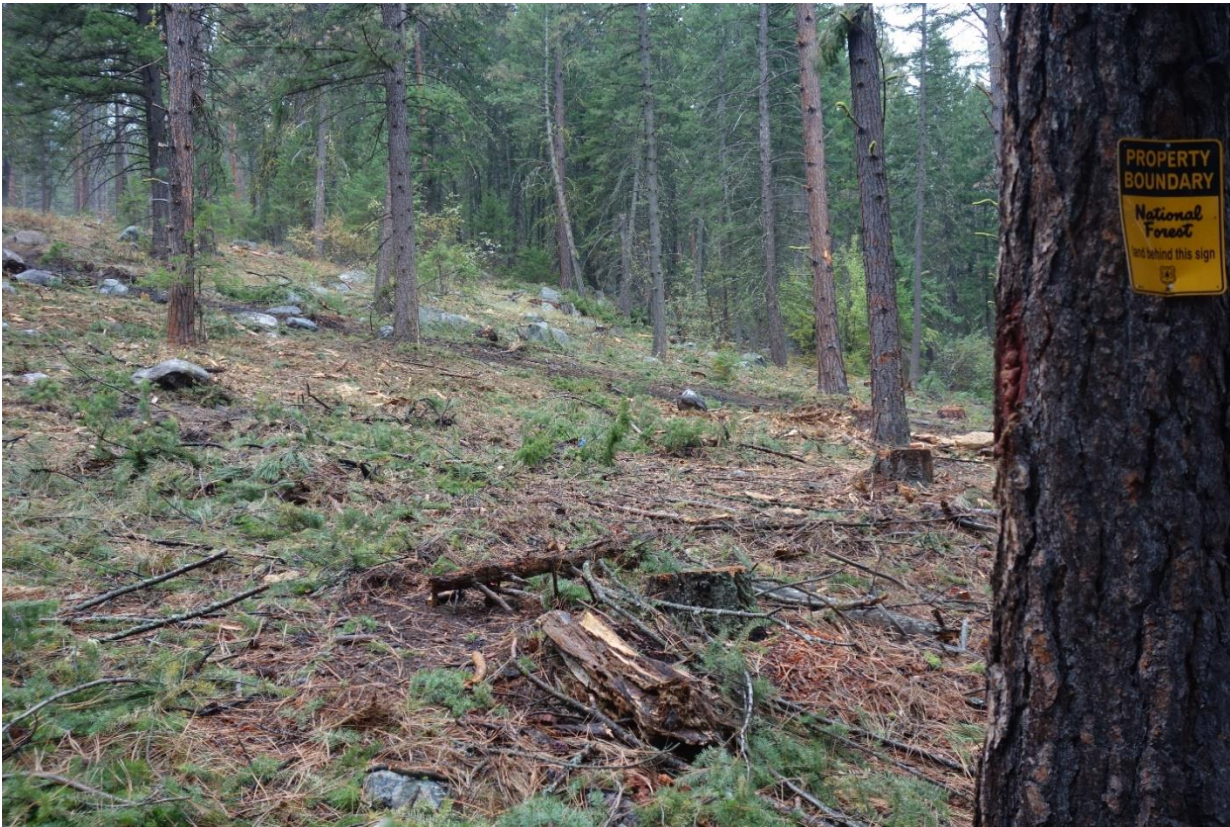
Looking west from the Keeling land across the narrowest part (250' wide) of the shaded fuel break south of the Mill Creek trailhead road. The haul road used by the tractor-forwarders runs through the middle of the photo. The Keeling land had a 40-year-long climate

study site as well as botanical study plots that straddled the BNF border. Both are severely and negatively impacted by this project. Photo 10-1-2022.

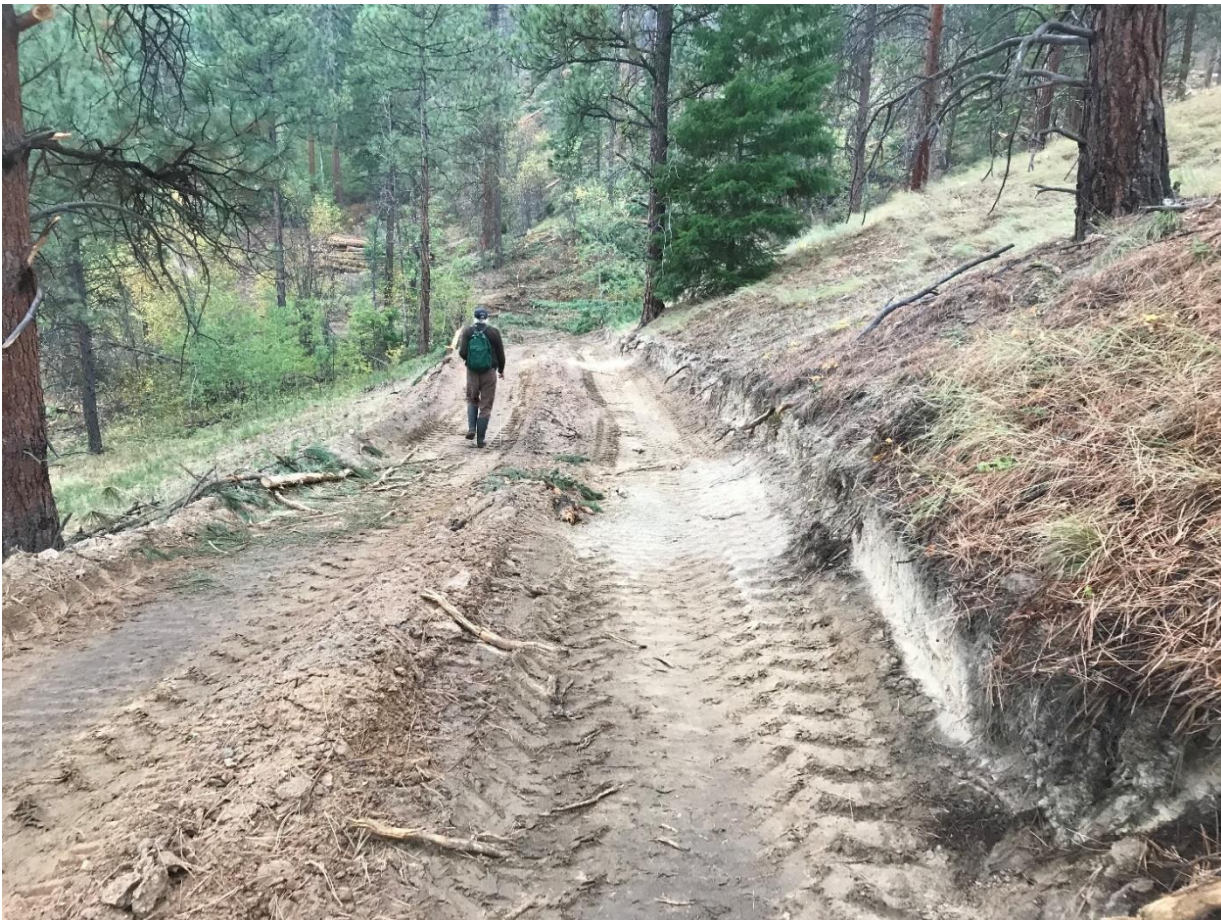
Reconstructed road used to haul logs out of the southern part of the commercial logging area. Steve Brown commented in newspaper articles that the normal bulldozed fire lines "cause a lot of damage", in contrast to this light-on-the-land approach. Photo 10-1-2022.

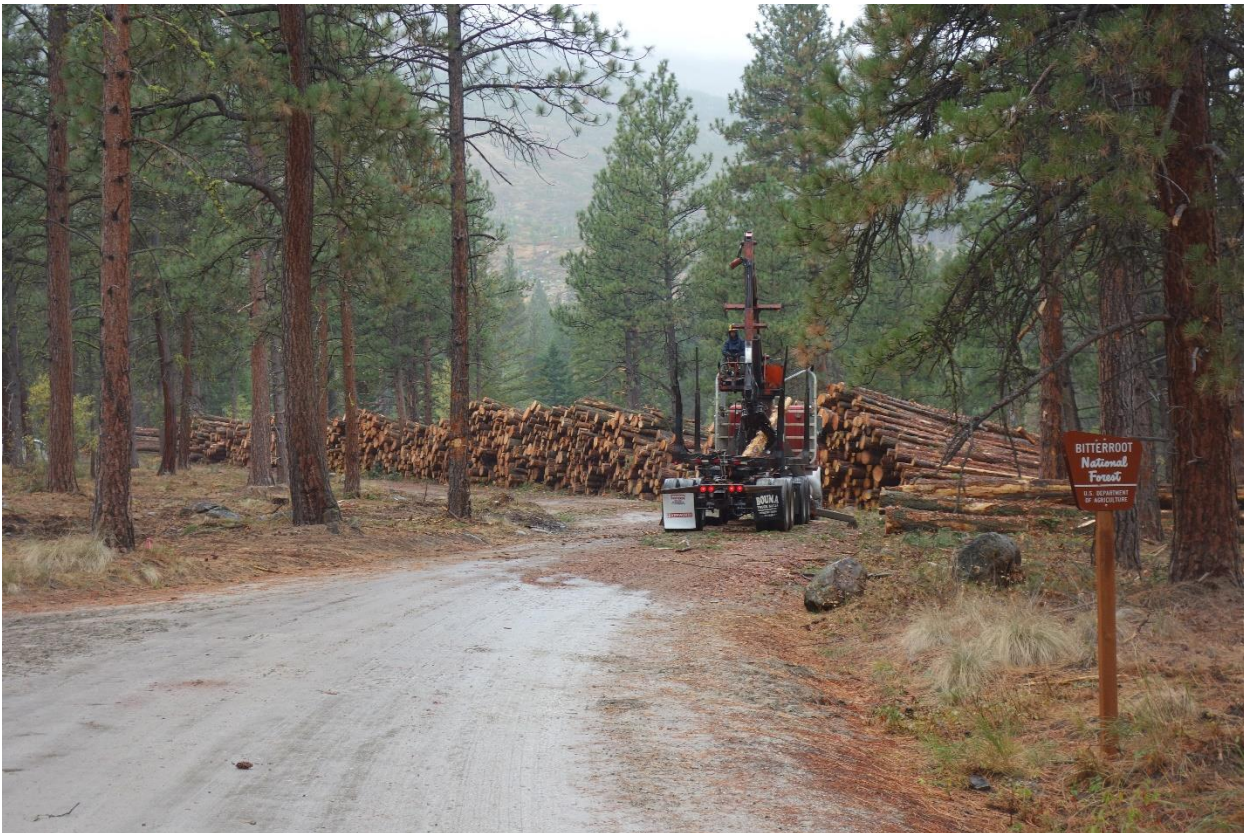
Log truck loading up at the Mill Creek trailhead log deck, taking them a couple miles down to the drop off on Dutch Hill Rd. Photo 10-1-2022.

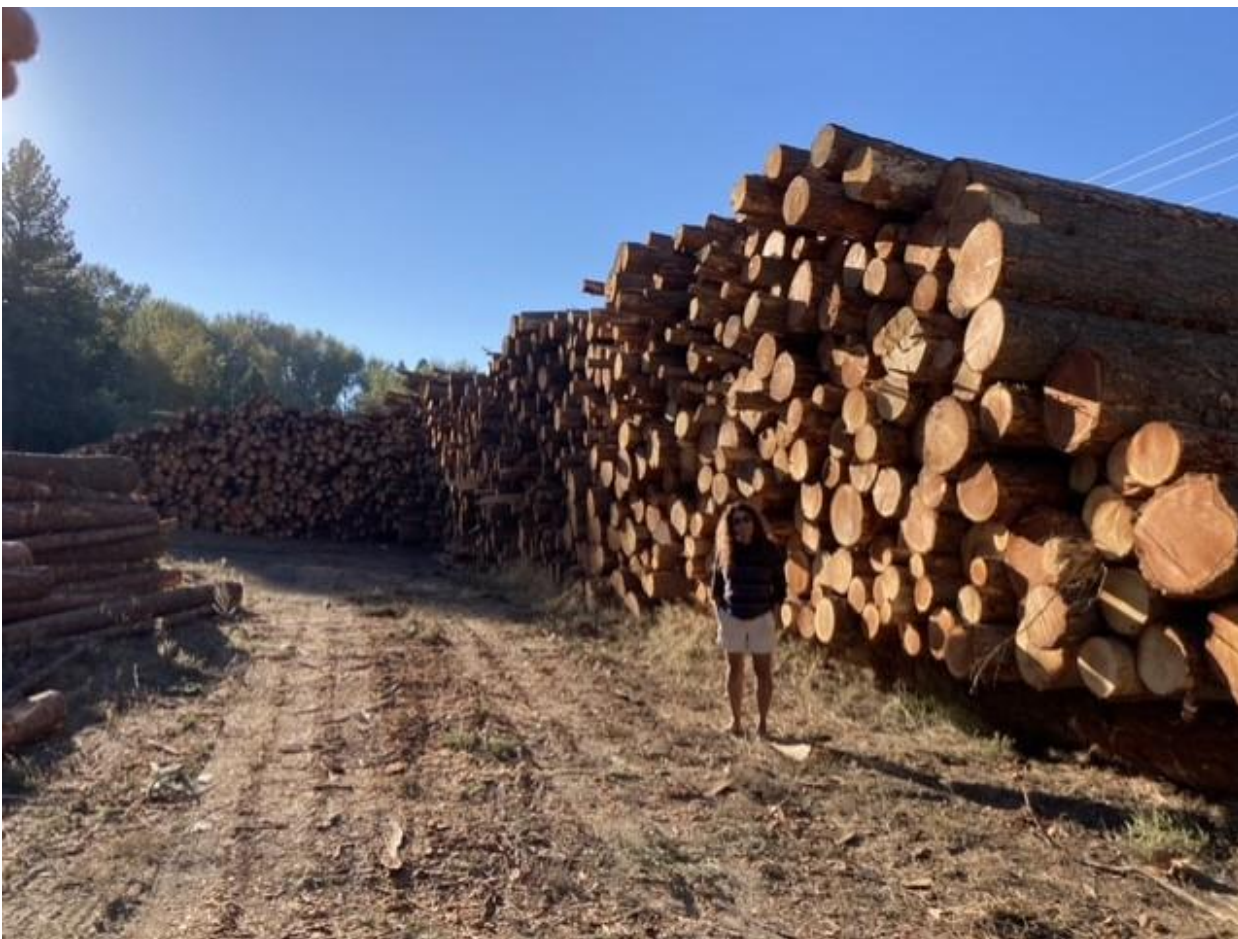
Log deck at the drop off on Dutch Hill Road resulting from the "shaded fuel break" near the Mill Creek Trailhead. Logs are transferred from the log deck at the trailhead (previous photo) to this location. These large trees tend to be fire-resistant and also store the most carbon.

They are the same mature trees that Executive Order 14072 orders the Forest Service to protect. 9-16-2022 photo.

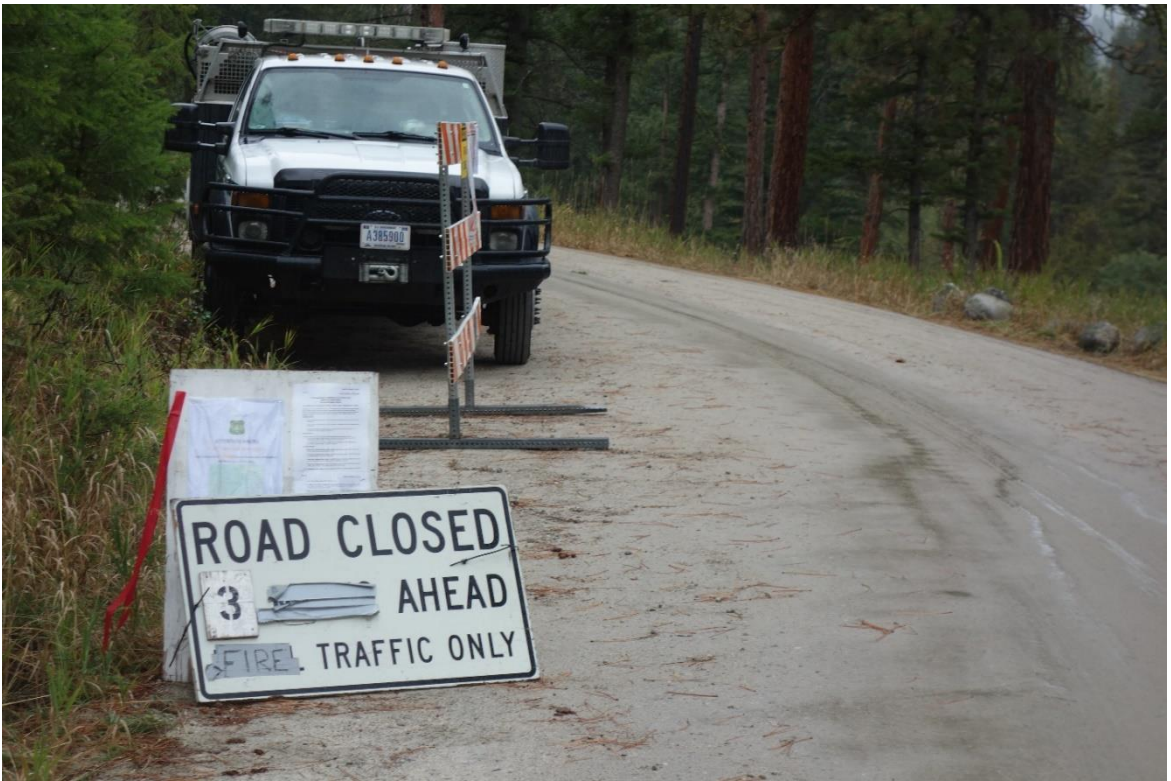
This sign at the closure on the trailhead road— "Fire Traffic Only". It was pouring rain (10-1-2022). This closure was still in place Oct 18. From it, the trailhead area with its large log decks is/was not visible to the public.

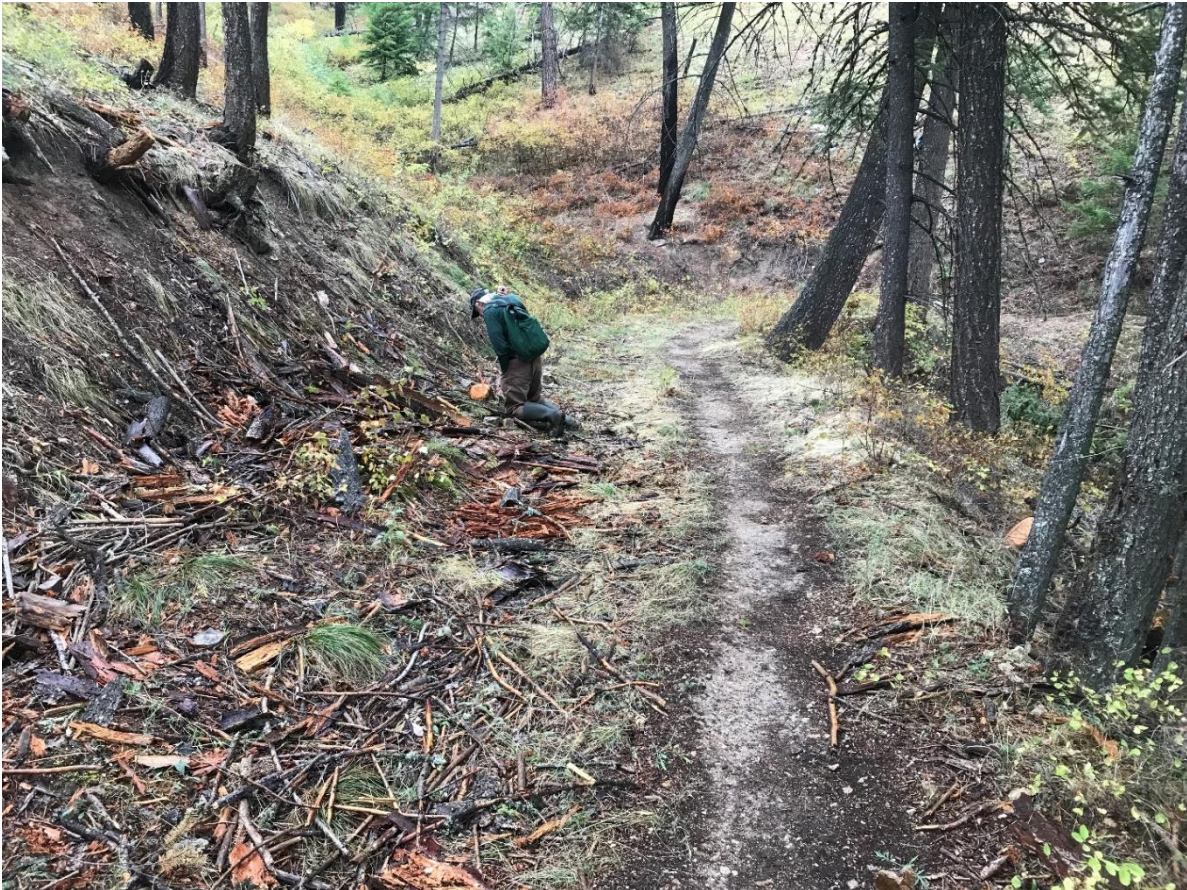
Hand line cut along the old irrigation ditch several hundred feet west of the commercial logging area, rehabbing the 2000 fire line. Dead trees and downed logs were cut up, and live trees were limbed. This work here was done after the commercial logging farther east had begun, according to local residents. In the Bodgett Creek area, where there

are few large trees on BNF land, this type of hand line was considered sufficient, even though the Blodgett fire (also more than 6 miles from the forest boundary) was larger and more active.

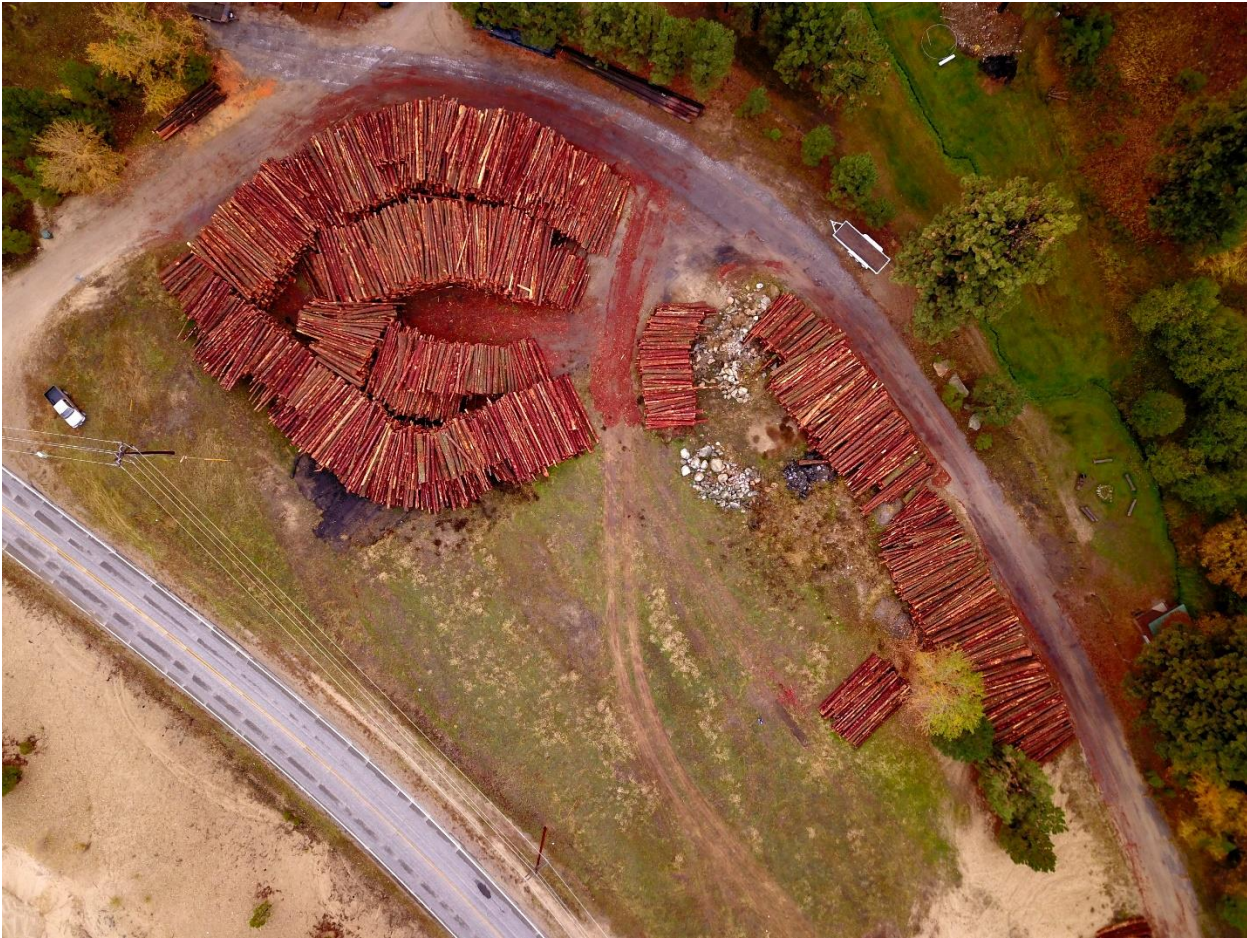
*Aerial view of
log deck
taken on
October 22,
2022*

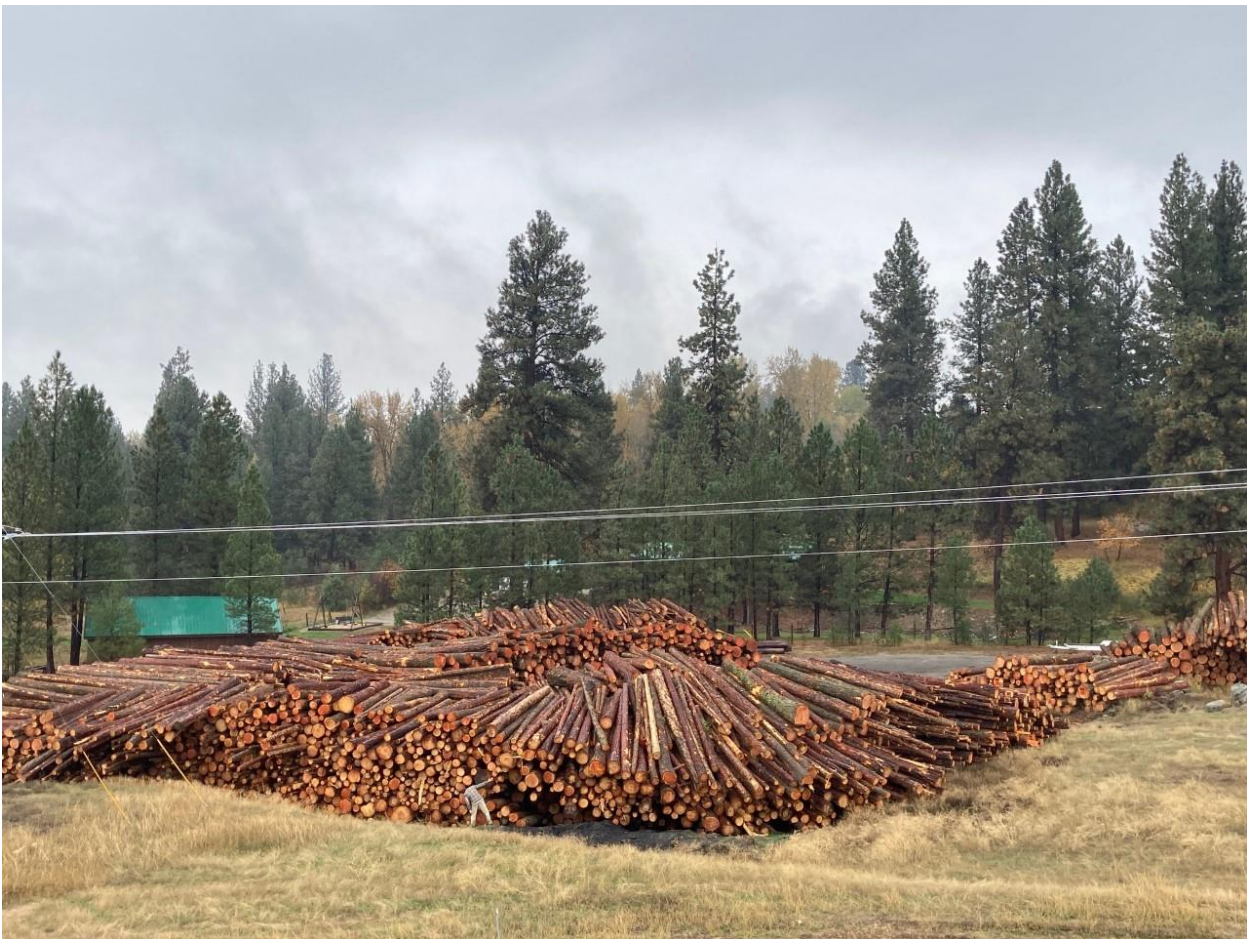
*Photo of log
deck taken
October 21,
2022 Note
the person
standing in
front of the
logs for scale.*
